Manhole Inspection Summary

Manhole # S17CC1003MH

Location Address: **3605 EDGEGREEN AVE**

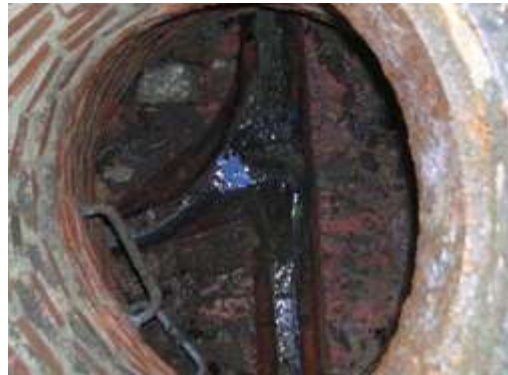
Top View

Corroded steps. Evidence of surcharge - Bench debris. Channel debris.

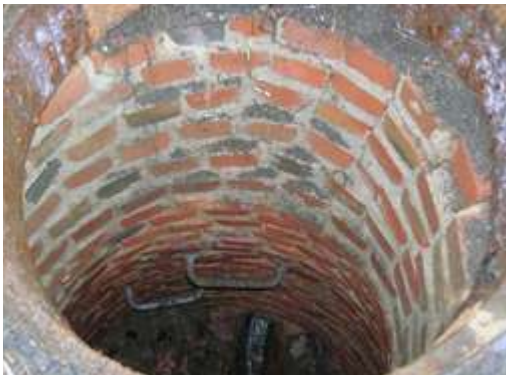
Defect

Frame offset. Adjustment infiltration

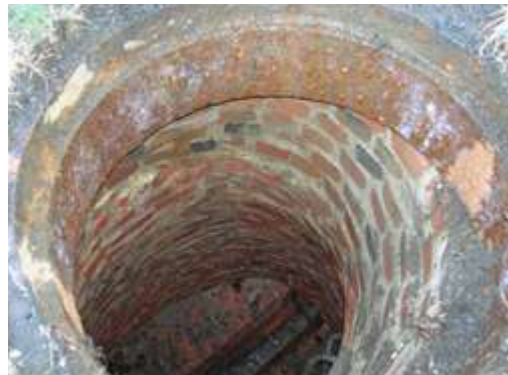
Defect

Frame offset. Adjustment and Corbel infiltration.

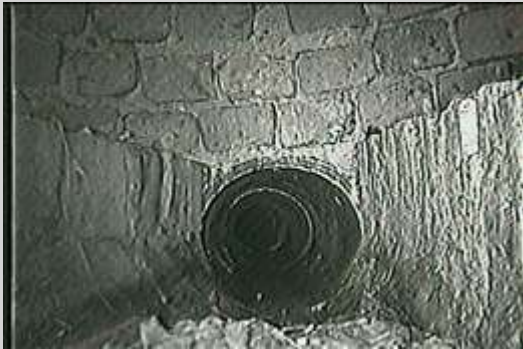
8 in. Circular Gravity Sewer Pipe Out @ 12 O'Clock

Infiltration: **Evidence** Pipe Seal Cond: **Unknown**

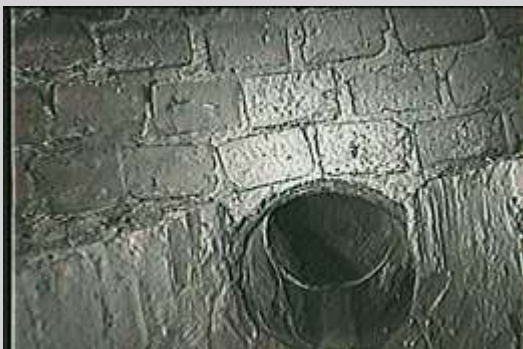
8 in. Circular Gravity Sewer Pipe In @ 6 O'Clock

Infiltration: **Evidence** Pipe Seal Cond: **Unknown**

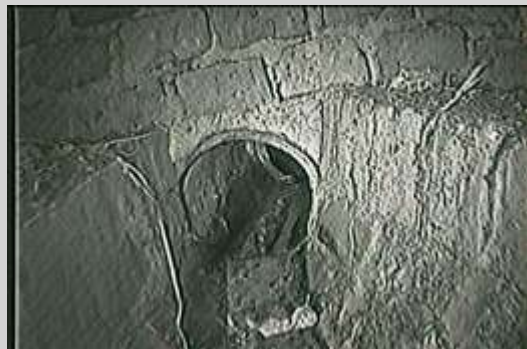
6 in. Circular Gravity Sewer

Bench root intrusion.

Infiltration: **Evidence**
